# Juno's Lessons Learned at Earth Fly-by

Larry Bryant, Juno Mission Operations Assurance Manager Office of Safety and Mission Success

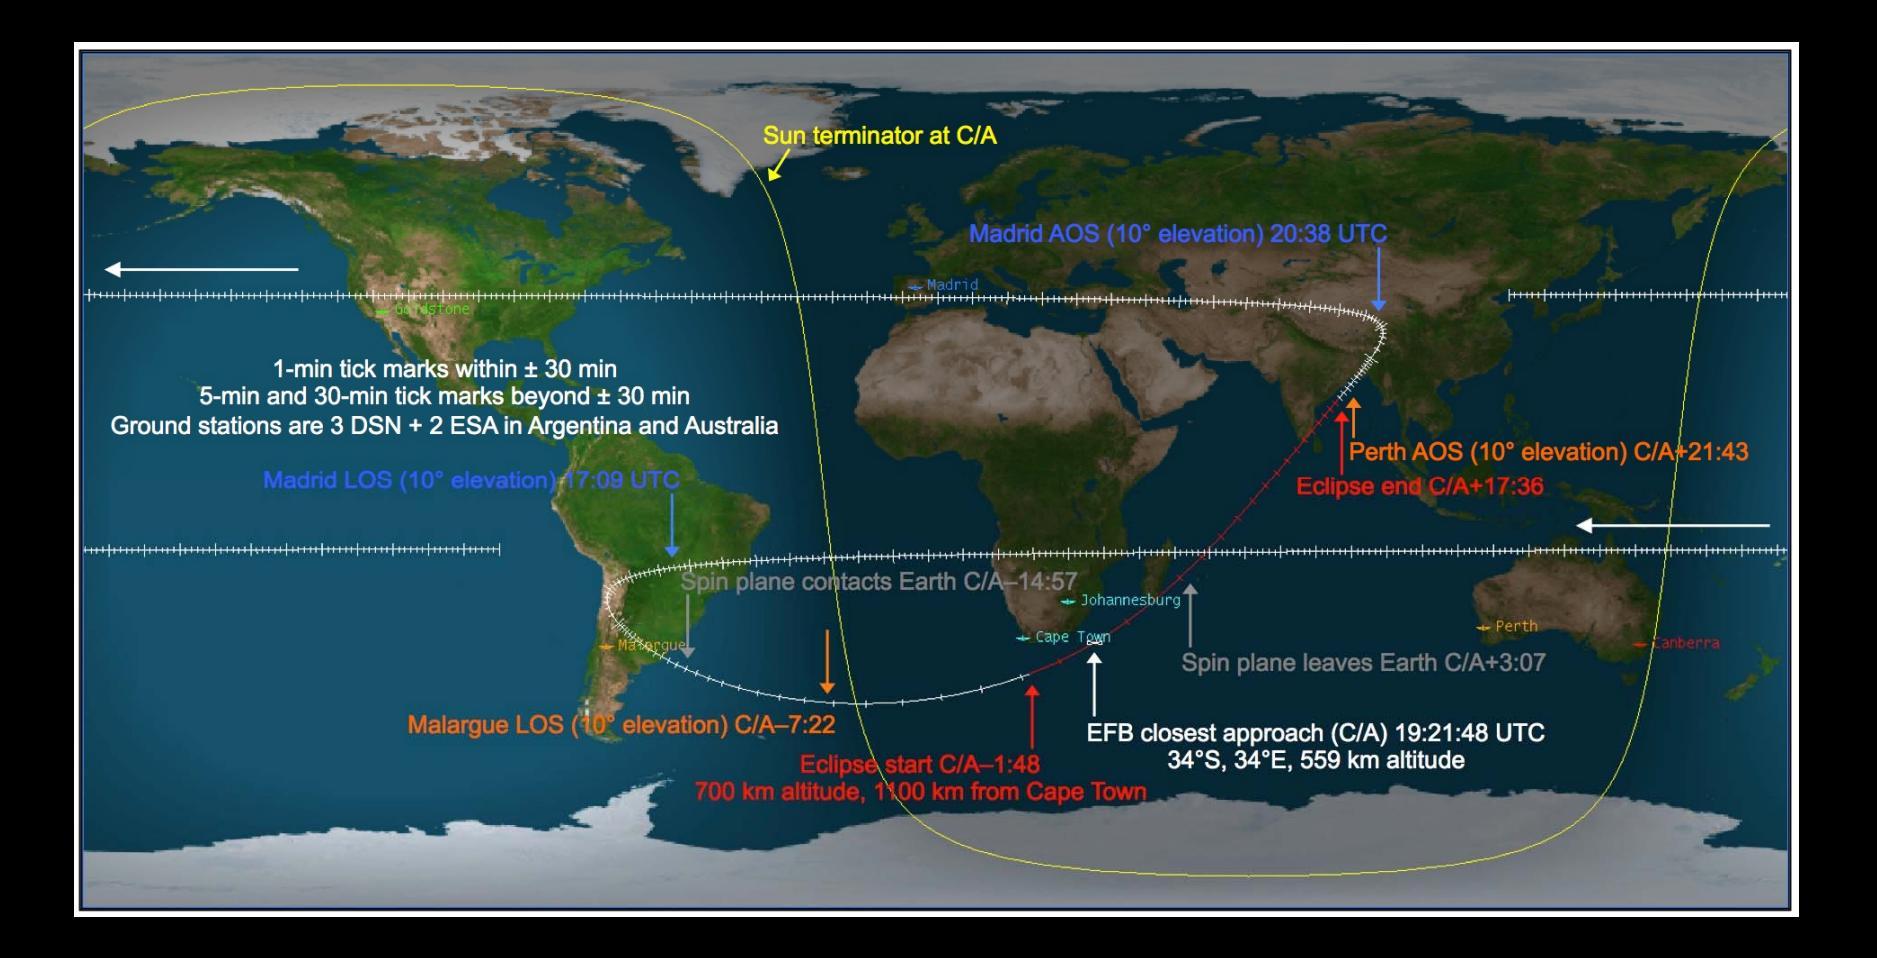
#### Eclipse and Safe Mode #1

- Communication among the teams on the project regarding the battery management was in terms of state of charge
- Further, the work was managed as battery state of charge
- During eclipse state of charge drops from 50% to 46% over about 20 minutes
  - Understood that 38% SOC was the fault protection trigger point

- In reality, fault protection triggers on battery voltage at 28.7 volts
  - We entered eclipse at 29.3 volts as planned
  - With no power from the solar arrays and full load the battery droped 0.4 volts to 28.9 volts.
- We didn't properly analyze the situation based on this difference and underestimated the margins

- That 48.4% SOC with 5.11 amp current draw, voltage is <28.7</li>
- If a fully validated model that properly predicted the battery voltage behavior were in use and had been run (and reviewed) for the EFB case, this condition would have been seen and could have been avoided.
- We had an inadequate process and poor communication for modeling and analysis of power system behavior
